# QUALITY INSPECTION REPORT

PV Supervision,

Automatic PV supervision  
from thermographic pictures

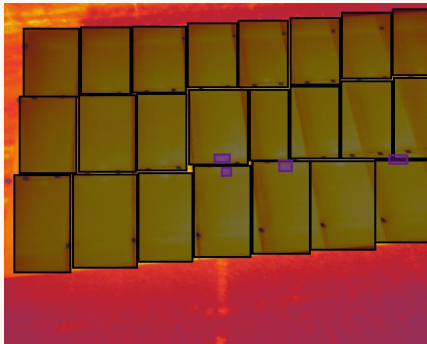
20171122\_124319.jpg

**4 Hot spots**

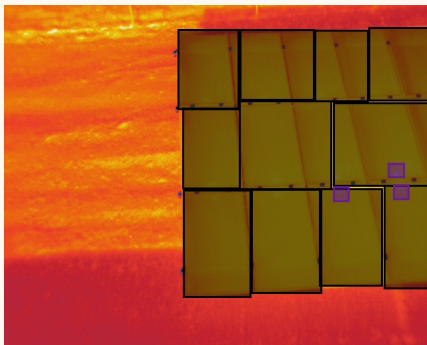
20171122\_124315.jpg

**3 Hot spots**

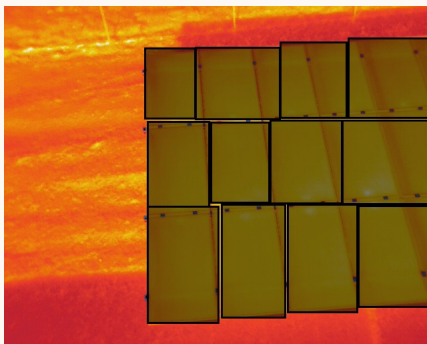
20171122\_124317.jpg

**No issues found**

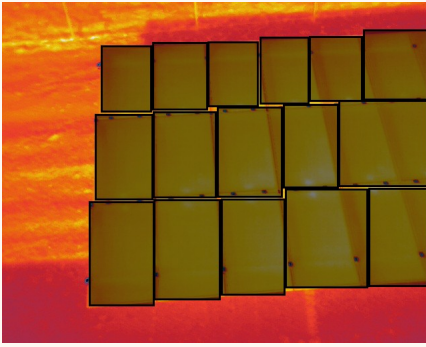
20171122\_124318.jpg

**No issues found**

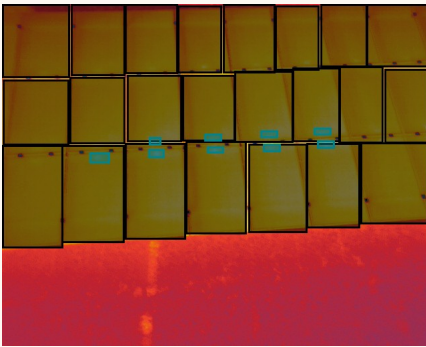
20171122\_124320.jpg

**No issues found**
